**MARYLAND HISTORICAL TRUST
DETERMINATION OF ELIGIBILITY FORM**

Property Name: Henry Boothe Farmhouse Inventory Number: SM-459
Address: 46212 Drayden Road (md 237) (MD 244) Historic district: yes ☒ no
City: Drayden Zip Code: 20630 County: Saint Marys
USGS Quadrangle(s): Saint Marys City
Property Owner: Henry and Stanley Boothe Tax Account ID Number: 1902002035
Tax Map Parcel Number(s): 30 Tax Map Number: 62
Project: MD 237 from MD 235 to Pegg Rd Agency: SHA
Agency Prepared By: SHA
Preparer's Name: Kathryn Barrett Date Prepared: 11/26/2007
Documentation is presented in: Maryland Historical Trust
Preparer's Eligibility Recommendation: X Eligibility recommended _____ Eligibility not recommended
Criteria: X A B X C D Considerations: A B C D E F G
Complete if the property is a contributing or non-contributing resource to a NR district/property:
Name of the District/Property: _____
Inventory Number: _____ Eligible: yes Listed: yes
Site visit by MHT Staff yes X no Name: _____ Date: _____

Henry Boothe Farmhouse

Capsule Summary
SM-459
Henry Boothe Farmhouse
Drayden
Private

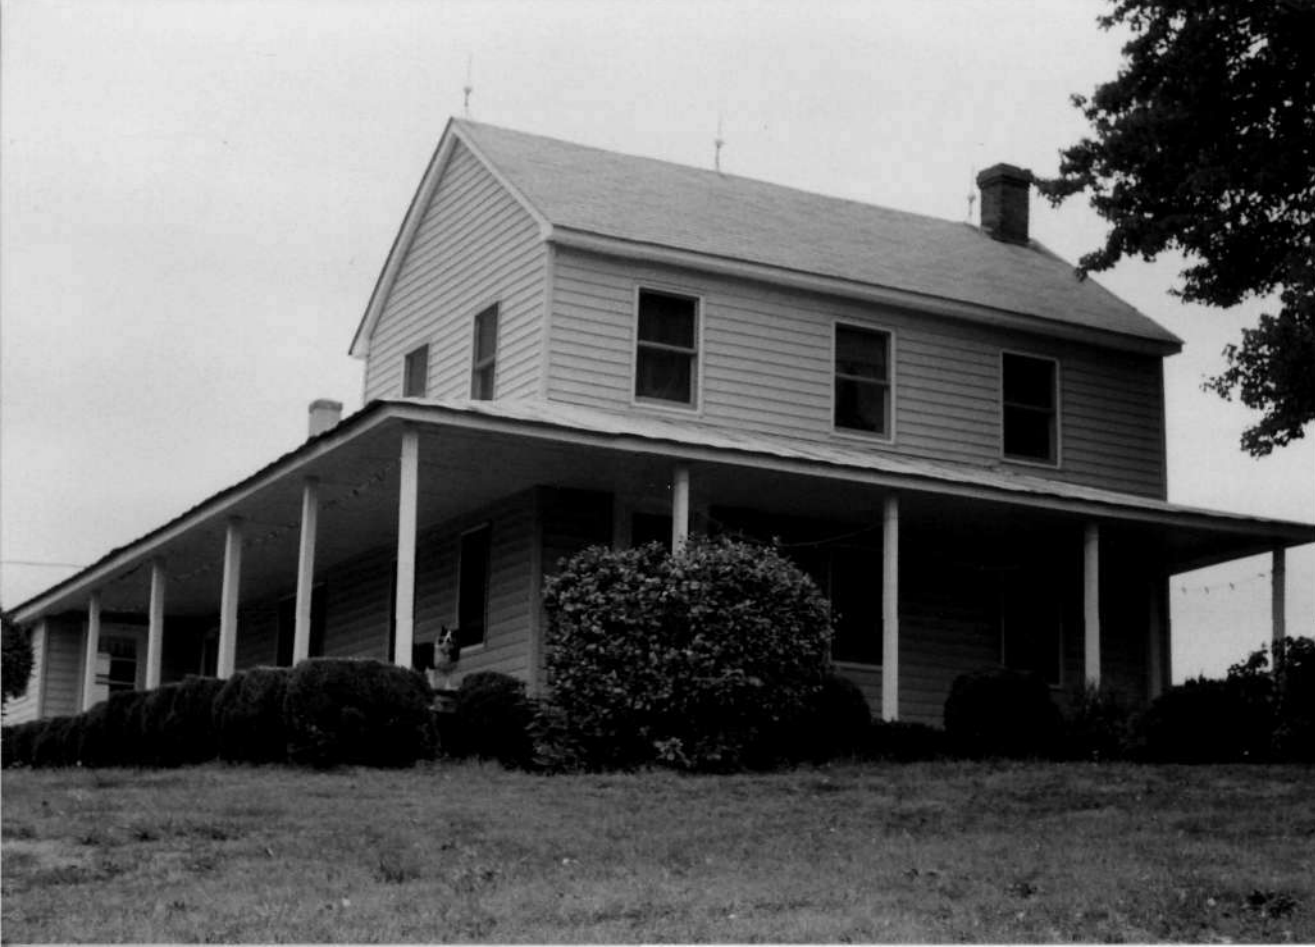
#1 of 16

View of the house facade (south side)

is clad in vinyl siding, which conceals the original clapboard beneath. A standing-seam-metal roof caps the original portion of the dwelling, while asphalt shingles sheath the 1920 addition (east wing). Metal finials punctuate both roof ridgelines. An interior, corbel-capped, brick chimney punctuates the north end of the eastern portion of the dwelling, while concrete-block chimneys punctuate the east and west ends of the adjacent, side-gable wing, which faces south. The main entry is located in the southern bay of the east elevation of the east wing.

A one-story, full-width, hipped-roof, wrap-around porch dominates the façade (east elevation) and south elevation. Square posts support the porch roof, which is clad in corrugated-metal. Poured-concrete steps reach the porch on the east and south sides. The western end of the porch on the south elevation has been enclosed, which is a bathroom wing off of the main block of the dwelling. A glazed and paneled, wood door is located on the east side of the bathroom wing, which is reached from the porch. A secondary entry to the main block is located adjacent to the entry to the bathroom wing. It is comprised of a modern, glazed and paneled door behind an aluminum storm door. Replacement, one-over-one, double-hung, vinyl-sash fenestration has been installed throughout the building. The windows are hung singly in a symmetrical arrangement; however, one paired window is located on the first story of the south elevation of the west wing.

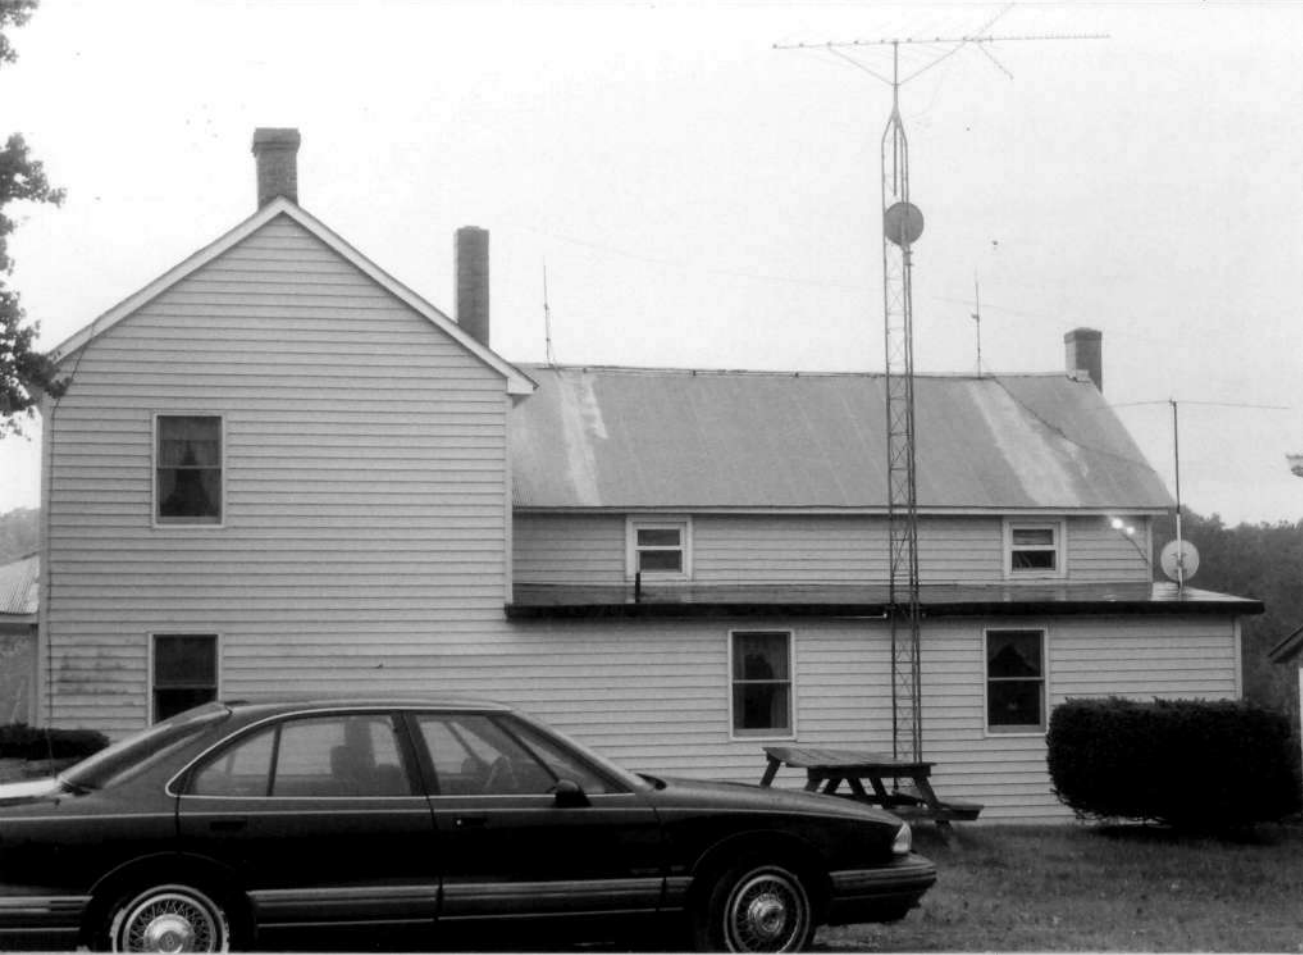
#2 of 16

View of the back of the house (north side).

The north elevation features a one-story, shed-roof addition. It extends from the north elevation of the original dwelling and the west elevation of the east wing. The addition is clad in vinyl siding and topped by a metal-clad roof. Two windows pierce the north elevation of this addition.

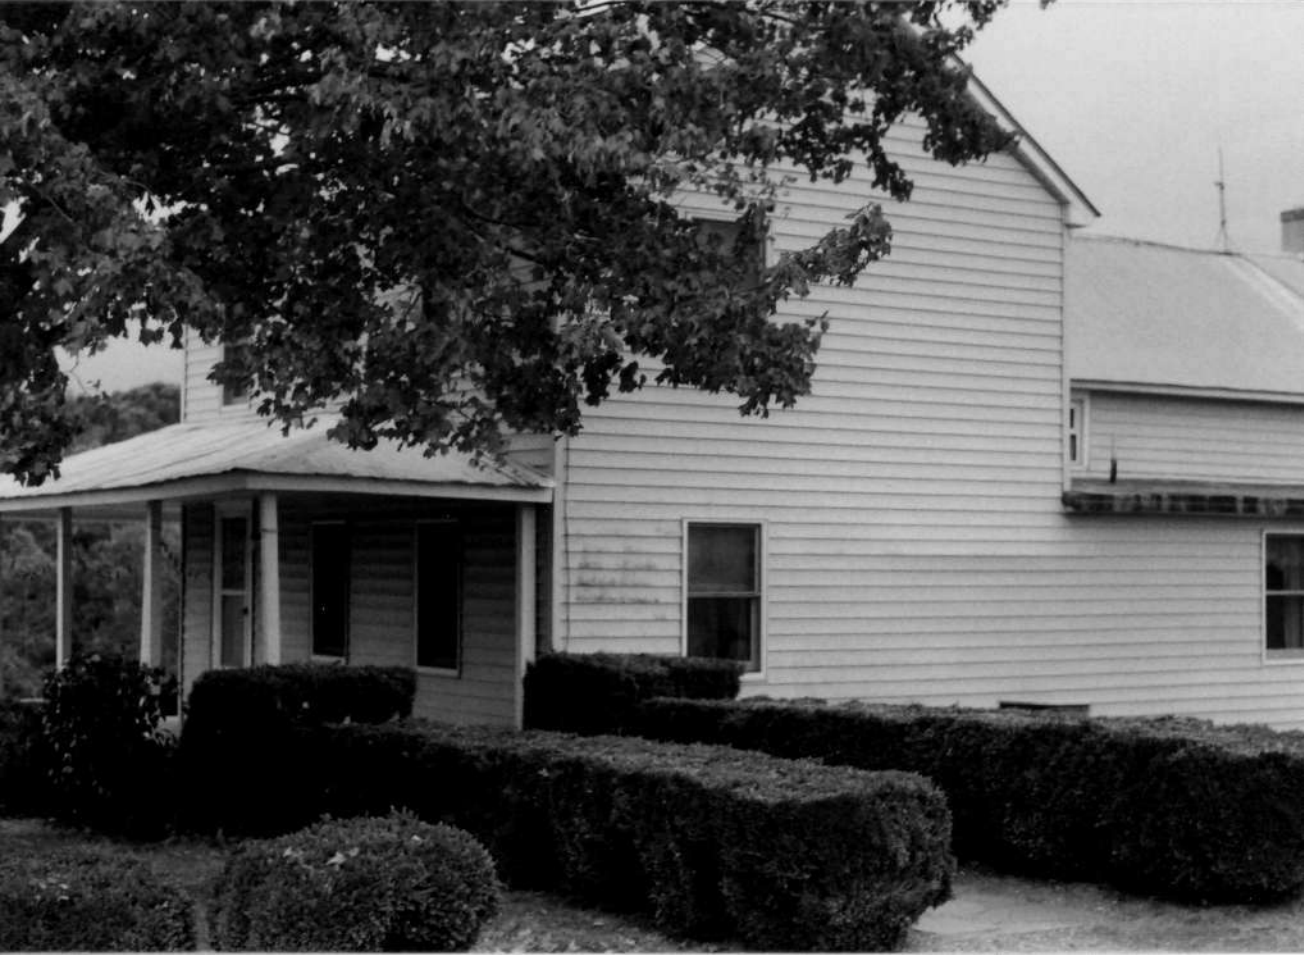
#3 of 16

View of the east side of the house.

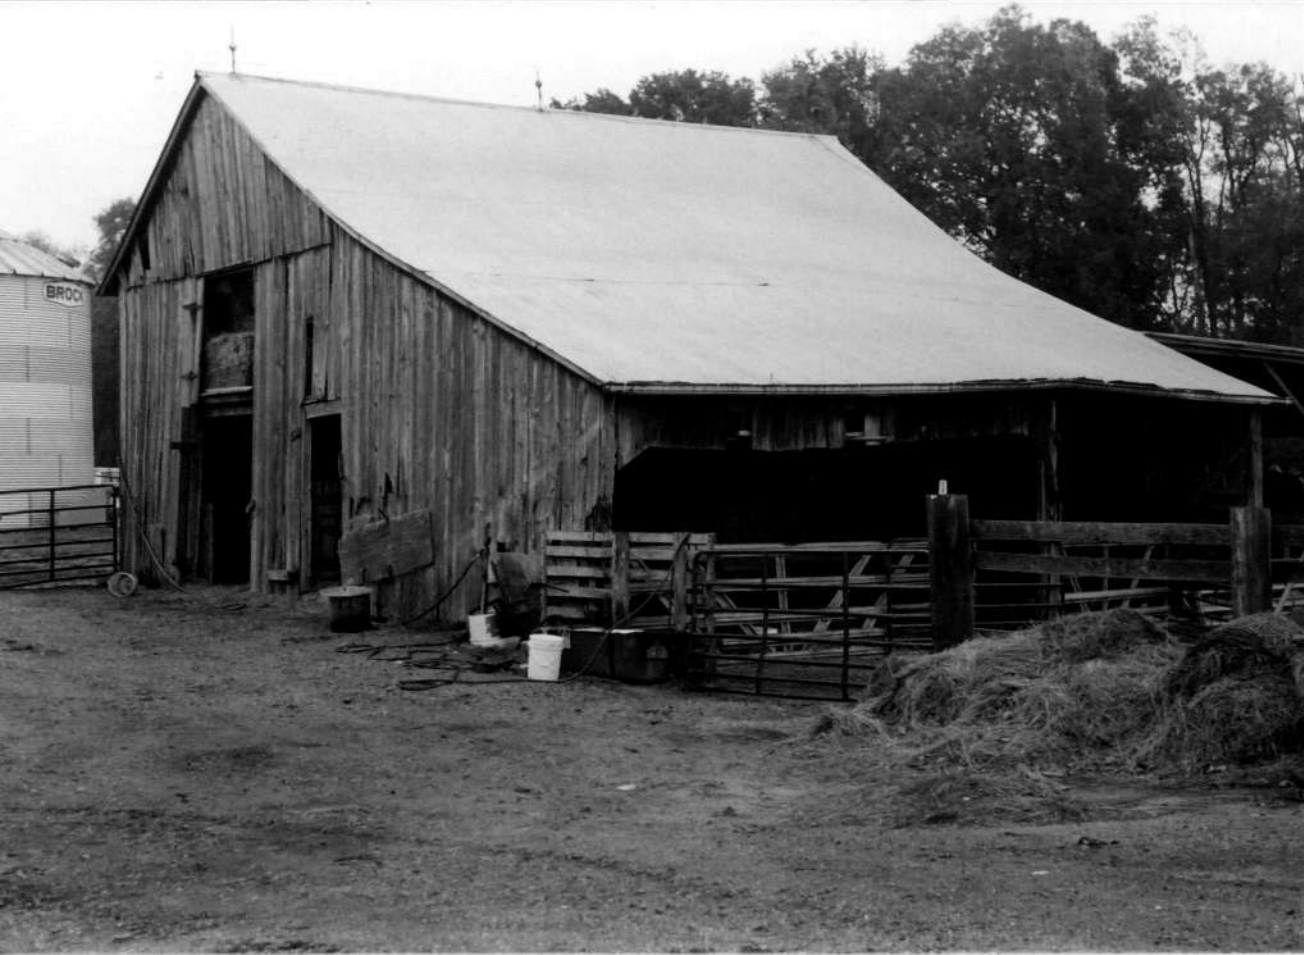
#4 of 16

View of the livestock and Hay barn.

The livestock and hay barn is a post-on-sill frame structure composed of a hay loft, and enclosed livestock pens. The rectangular building is characterized by a saltbox form with a continuous sloping roof over a shed-roof extension of the south elevation. Vertical wood planks clad the building while metal sheeting protects the gabled roof. The south elevation consists of two open-bays leading into a fence-enclosed pig sty. The barn likely dates from the early 1900s.

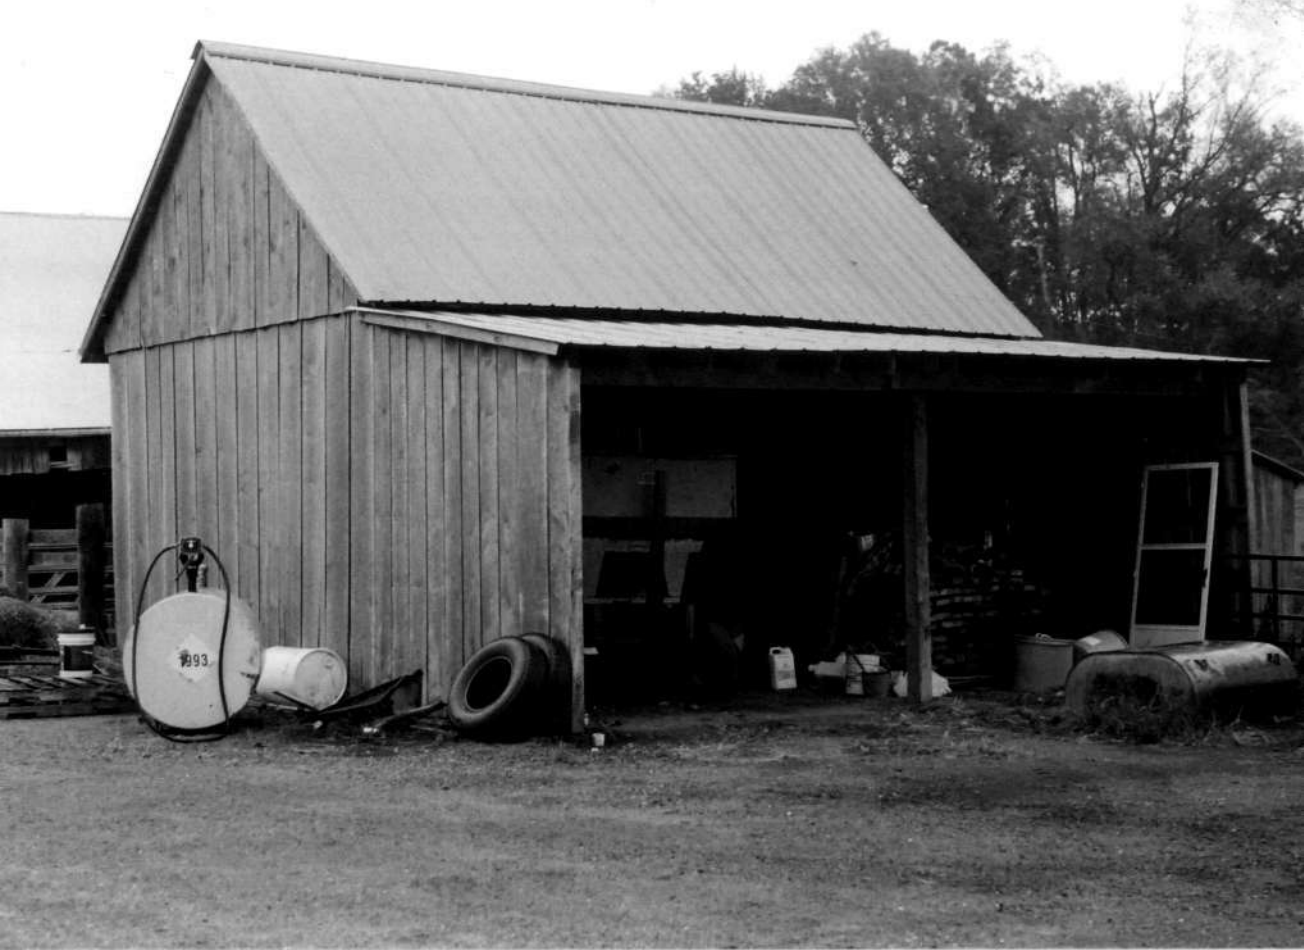
#5016

view of the equipment farm.

A small rectangular shed is located northeast of the main house and is used to house large equipment. The gable-roofed frame building is supported on a concrete slab and has an open-bay shed-roofed portion extending from the length of the south elevation. Vertical wood planking clads the building and a standing-seam metal roof shelters the shed. The shed was likely constructed in the early to mid-1900s.

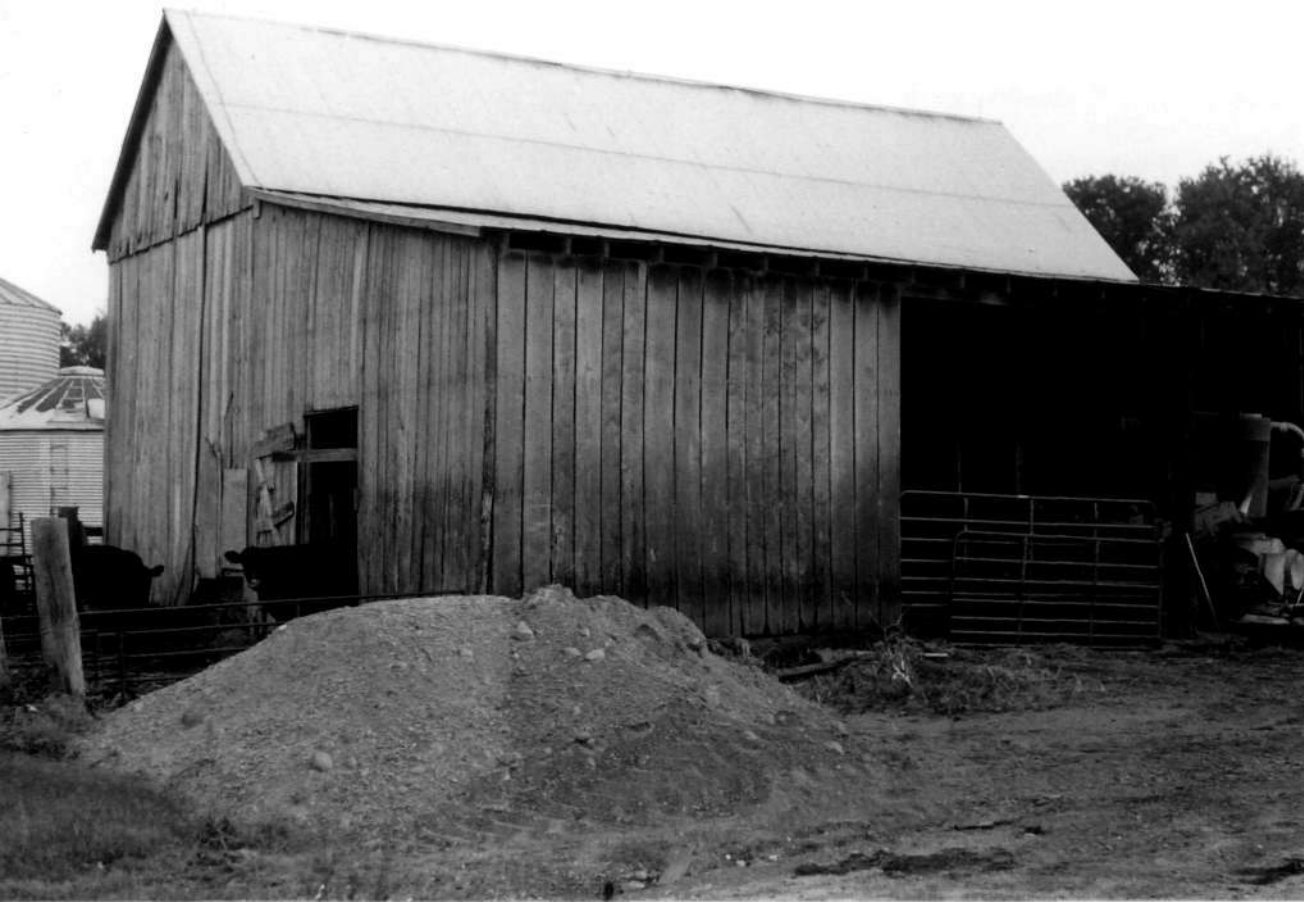
#6 of 16

View of the livestock and Hay Barn.

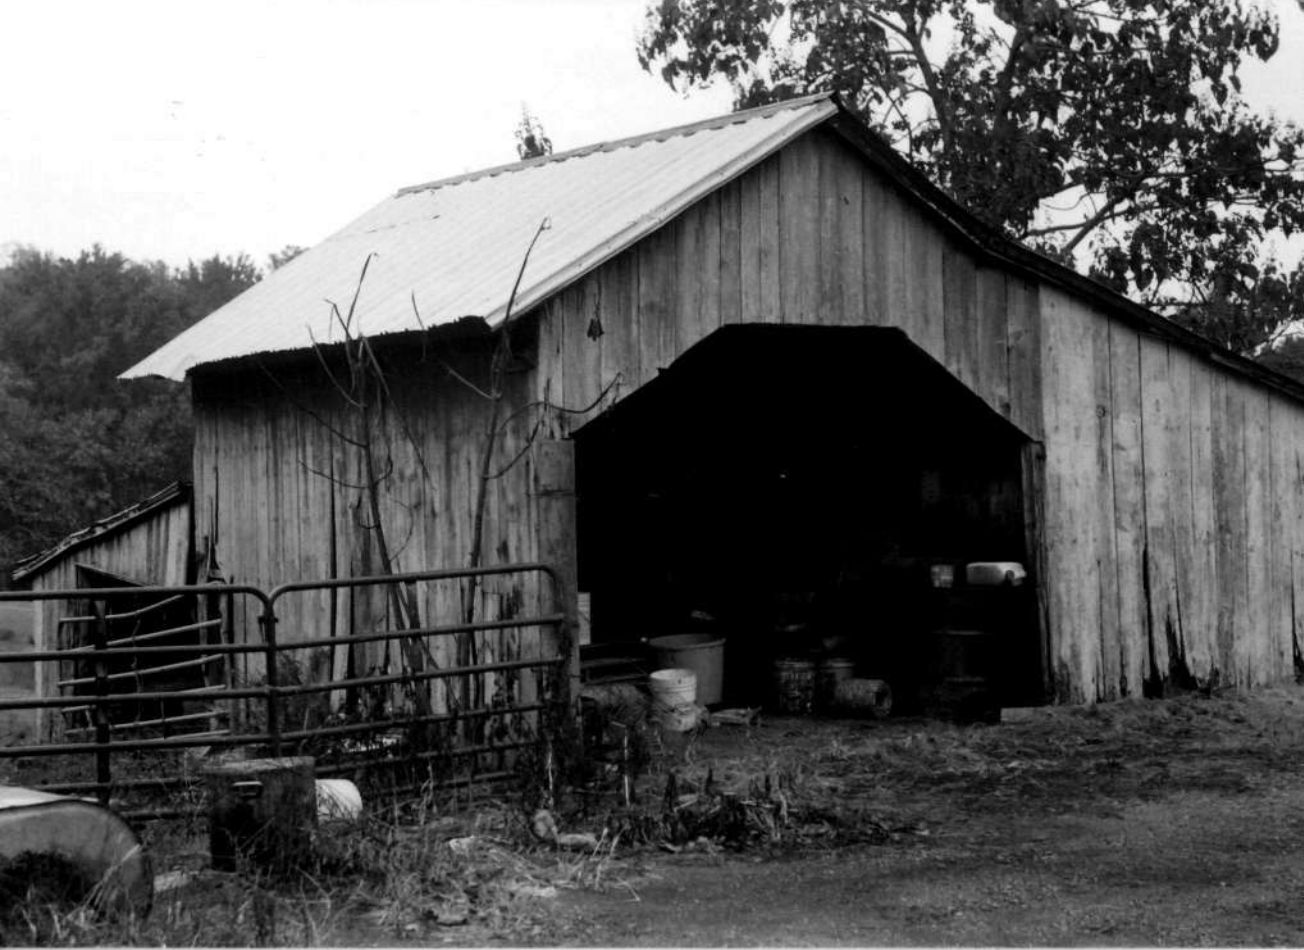
#7 of 16

View of the wagon barn.

An asymmetrical, front-gabled roof, one-bay-wide, frame tractor garage is located northeast of the dwelling. It is clad in vertical-board planks, and the roof is sheathed in corrugated metal. The garage bay is located on the west elevation. Shed-roof extensions are located on the east and south elevations.

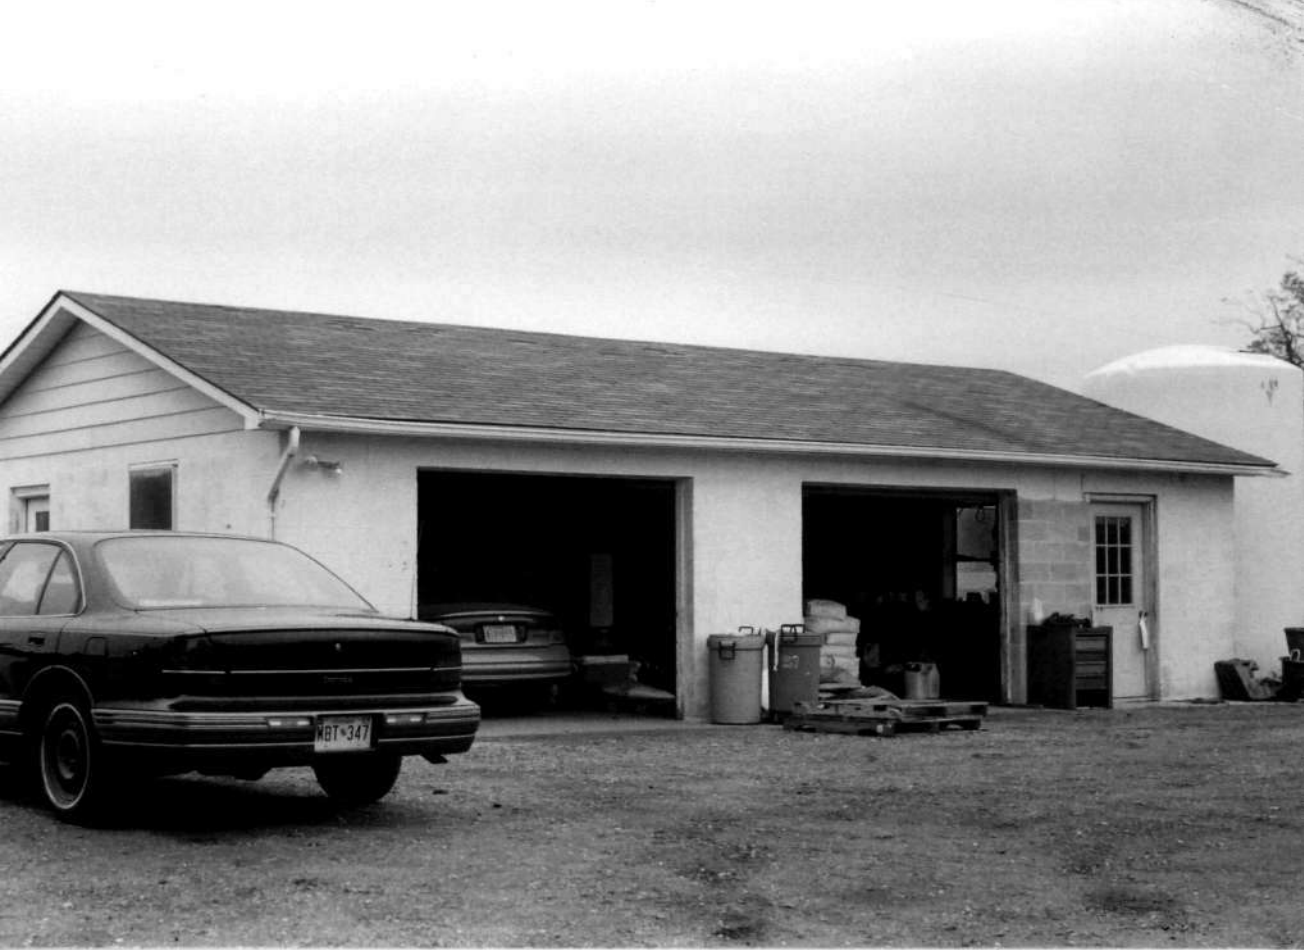
#8 of 16

View of the garage.

A one-story, side-gable, concrete-block garage is located just north of the pump house. It is situated along a north-south axis. It is fenestrated by double-hung, one-over-one, aluminum-sash windows. Two garage bays and a glazed and paneled entry door are located on the east elevation. The south elevation contains a secondary entry door and a window. The apexes of the gables are clad in aluminum siding, and the roof is clad in asphalt shingles. A metal pesticide tank, which rises slightly above the roof of the garage, is adjacent to the north gable end.

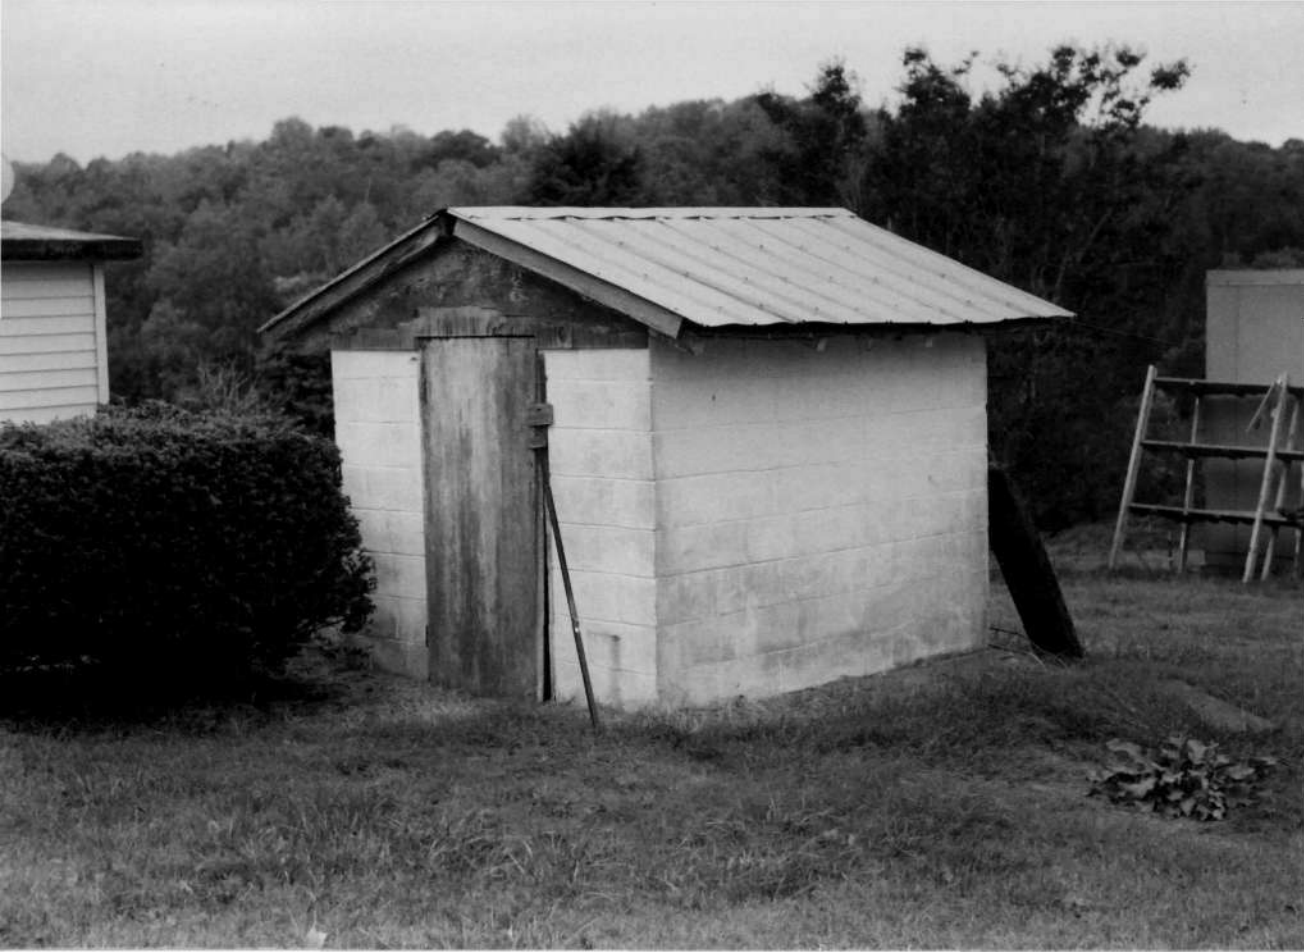
#90216

View of the pump house.

A one-bay-wide by one-bay-deep, front-gabled roof pump house is located just north of the northwestern corner of the farmhouse. It is oriented along an east-west axis. The building is constructed of concrete-block masonry. The front-gable roof is clad in standing-seam metal, and the rafter tails are exposed on the north and south eaves.

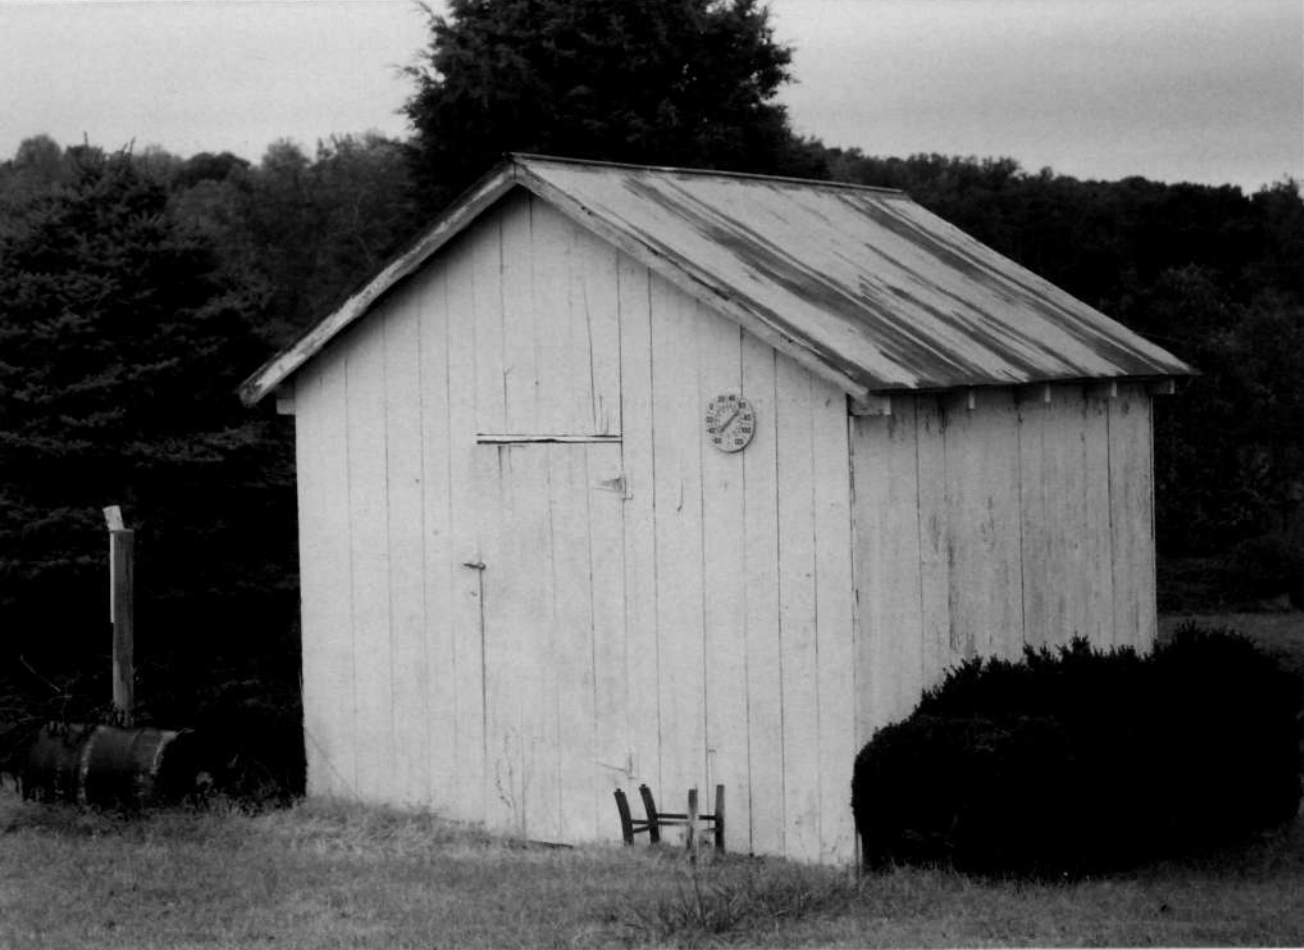
11 of 16

View of the meat house.

A one-bay-wide by one-bay-deep, frame meat house is located just west of the farmhouse. It is oriented along an east-west axis. The building is sheathed in vertical-wood planks, which are white washed. A single-leaf, board-and-batten door is located at the center of the east gable end. The front-gable roof is clad in standing-seam metal, and the rafter tails are exposed on the north and south eaves.

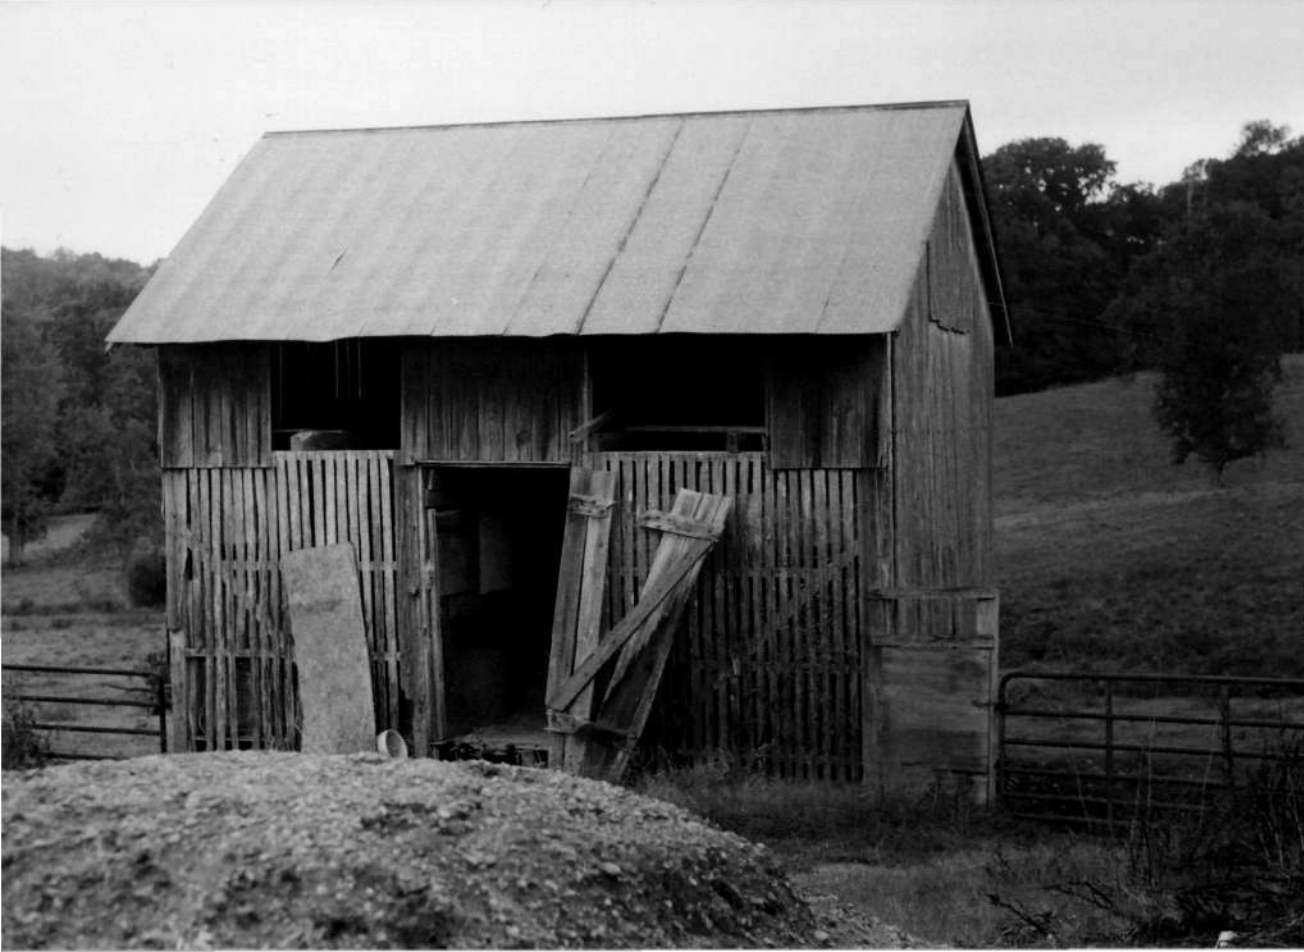
#12 of 16

View of the crib barn.

A frame double-crib barn, likely dating from the late 1800s, is located northwest of the house with the entrance oriented to the central yard formed by other outbuildings and fencing. The crib barn is one and one-half stories tall, rectangular in footprint, and sheltered with a side-gabled corrugated metal roof. The structure is composed of two separate interior bays and a loft space constructed with milled timbers. Widely-spaced vertical planks clad the front (east) side to provide ventilation for the drying corn. The other sides are clad in vertical planking. A metal cattle guard fence connects the corn crib to the cow pen and dairy cow barn.

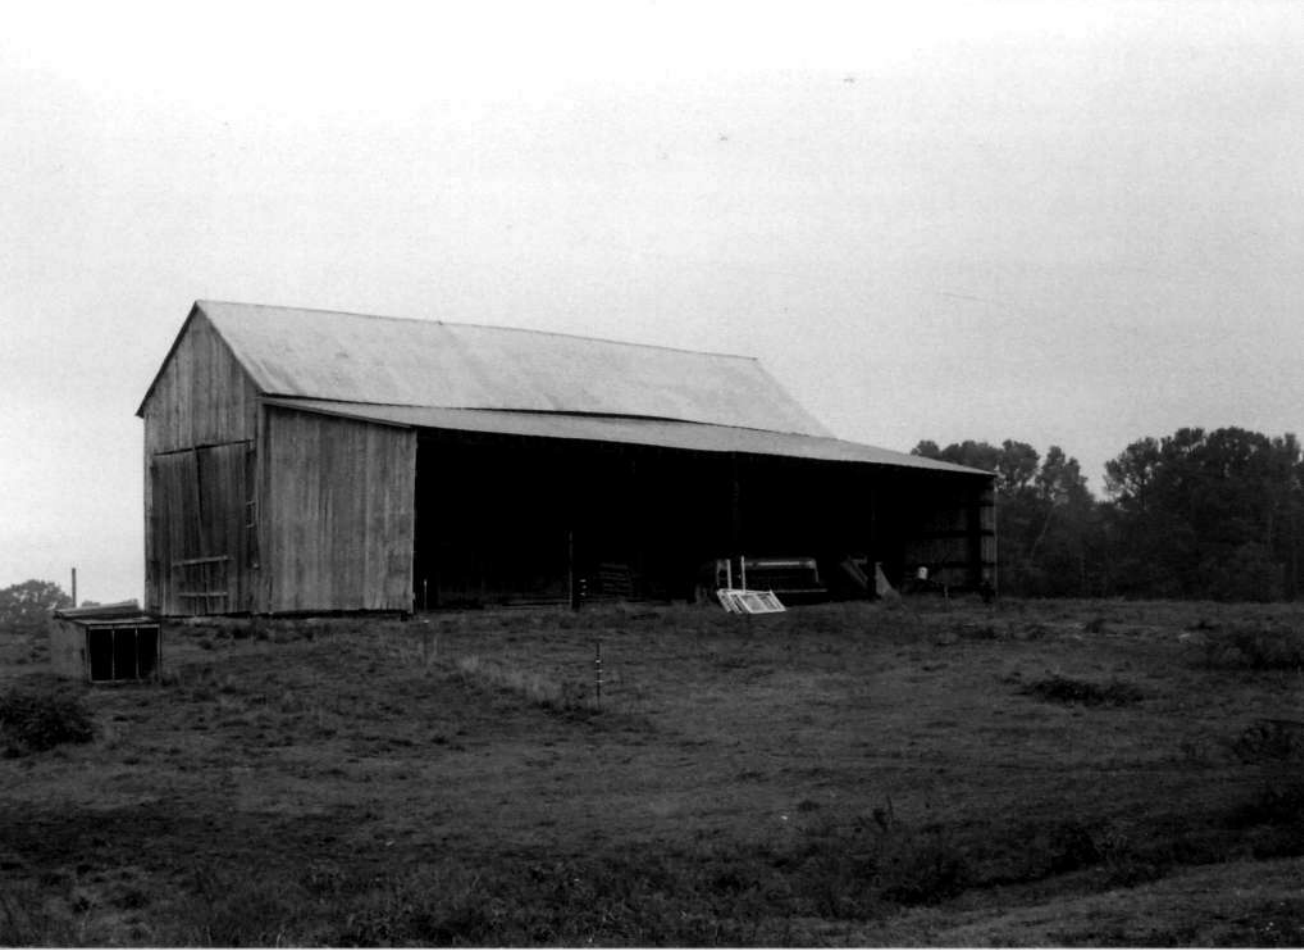
#130016

View of Tobacco Barn #1

The barn furthest from the house is a former tobacco barn that has been converted into equipment storage. The barn is rectangular in footprint with an end-gable roof clad in corrugated metal. A large shed-roofed addition extends from the east elevation and features four open bays allowing for sheltered equipment storage. A pair of large hinged doors is found on the south gable end. This feature, like the addition, is a modification made after the mid-1990s. Vertical wood planking clads the exterior. The MIHP form completed in the 1990s pictures a tobacco stripping shed located on the east side of this barn. The shed is no longer extant. The barn was likely constructed in the late 1800s.

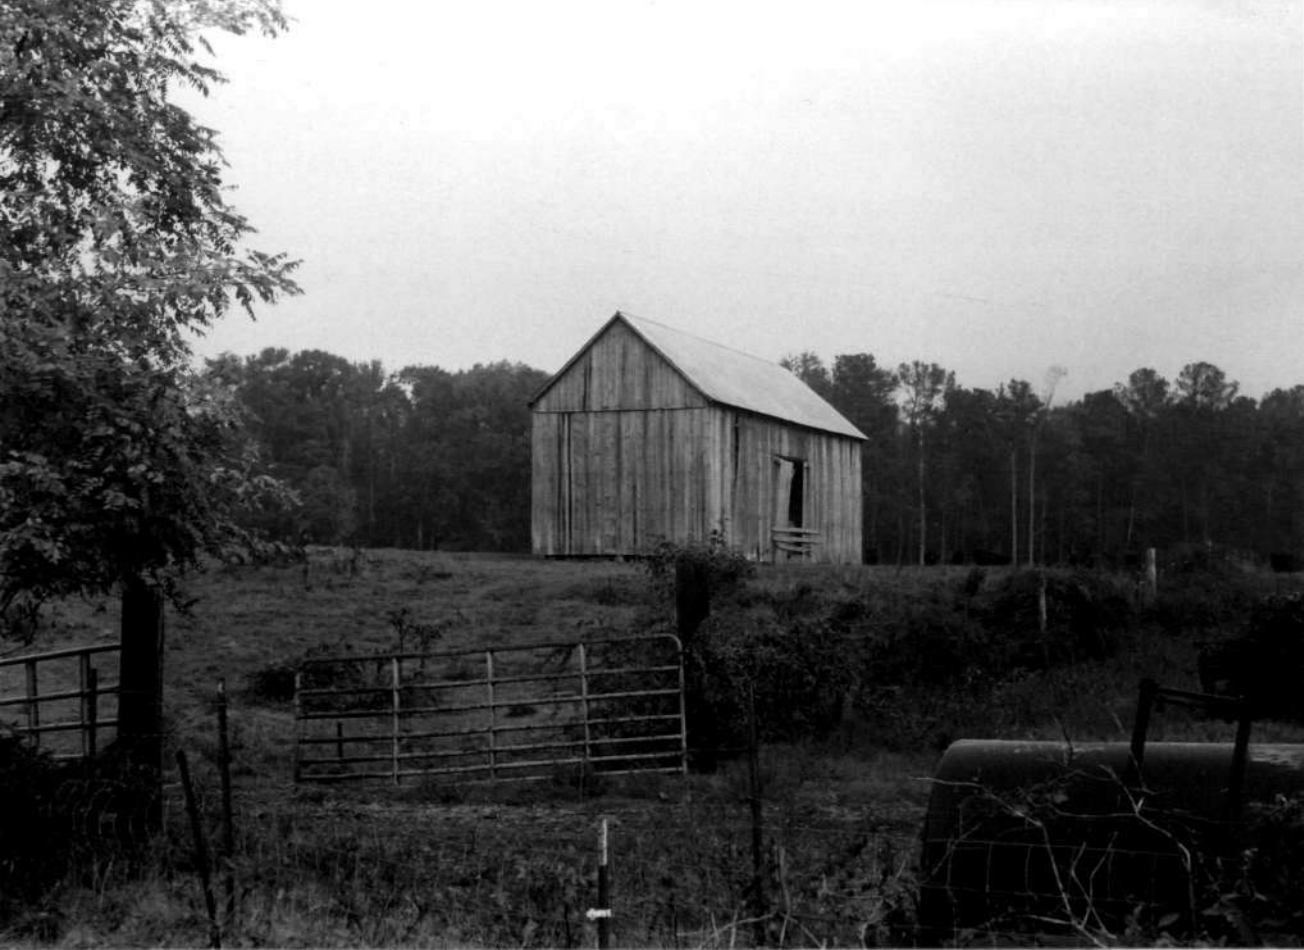
140016

view of tobacco barn #2

corrugated metal shelters the rectangular barn and a pair of large hinged doors is located on the east elevation. Vertical planking sheathes the exterior. The barn is currently used to store hay. The barn was likely constructed in the late 1800s.

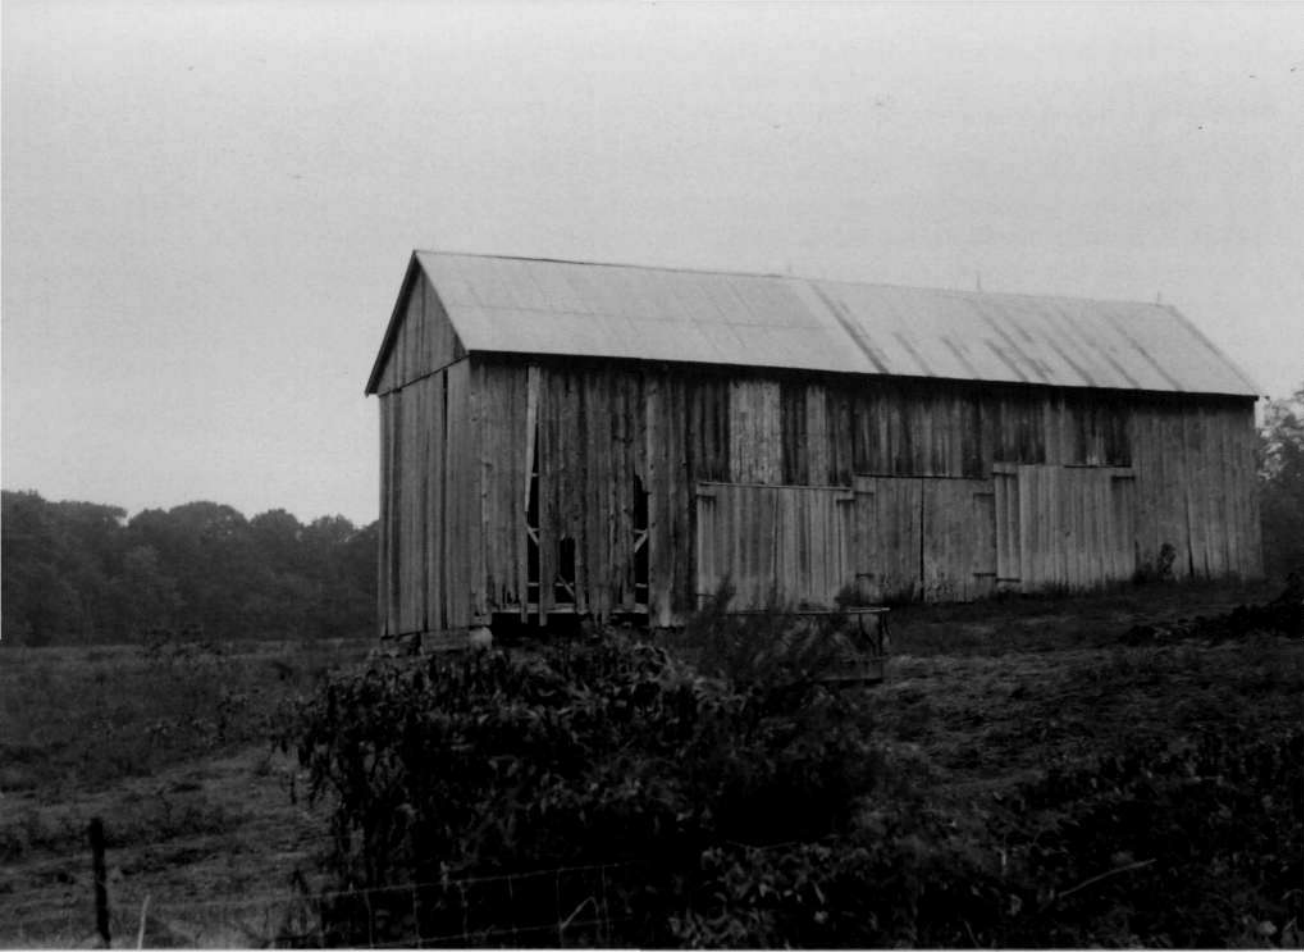
#15 of 16

View of tobacco barn #3

This tobacco barn is located north of the house with the long, or slope side facing the rear of the house. The rectangular barn is sheltered by a gable roof covered with corrugated metal. The barn features three pairs of hinged doors on the south elevation and characteristic hinged vertical panels to allow cross-ventilation. Though currently vacant, the barn was once used to dry and store tobacco. The barn is positioned perpendicular to a slope and has concrete piers supporting the sill plate on the west side. The barn was likely constructed in the late 1800s.

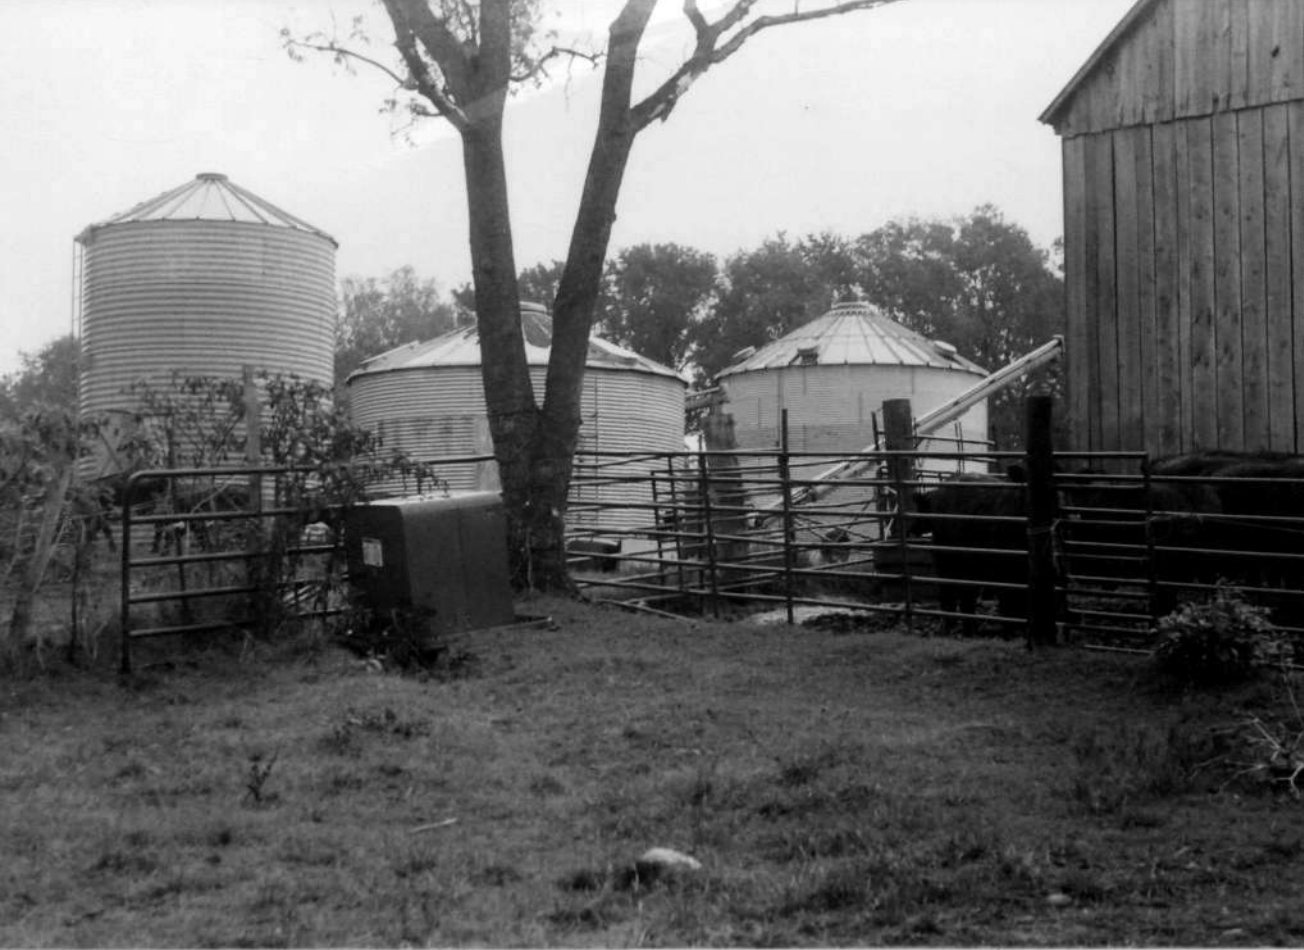
#16 of 16

View of the silos.

Varying sizes of modern, metal silos are located north of the cow barn and north of the hay barn.

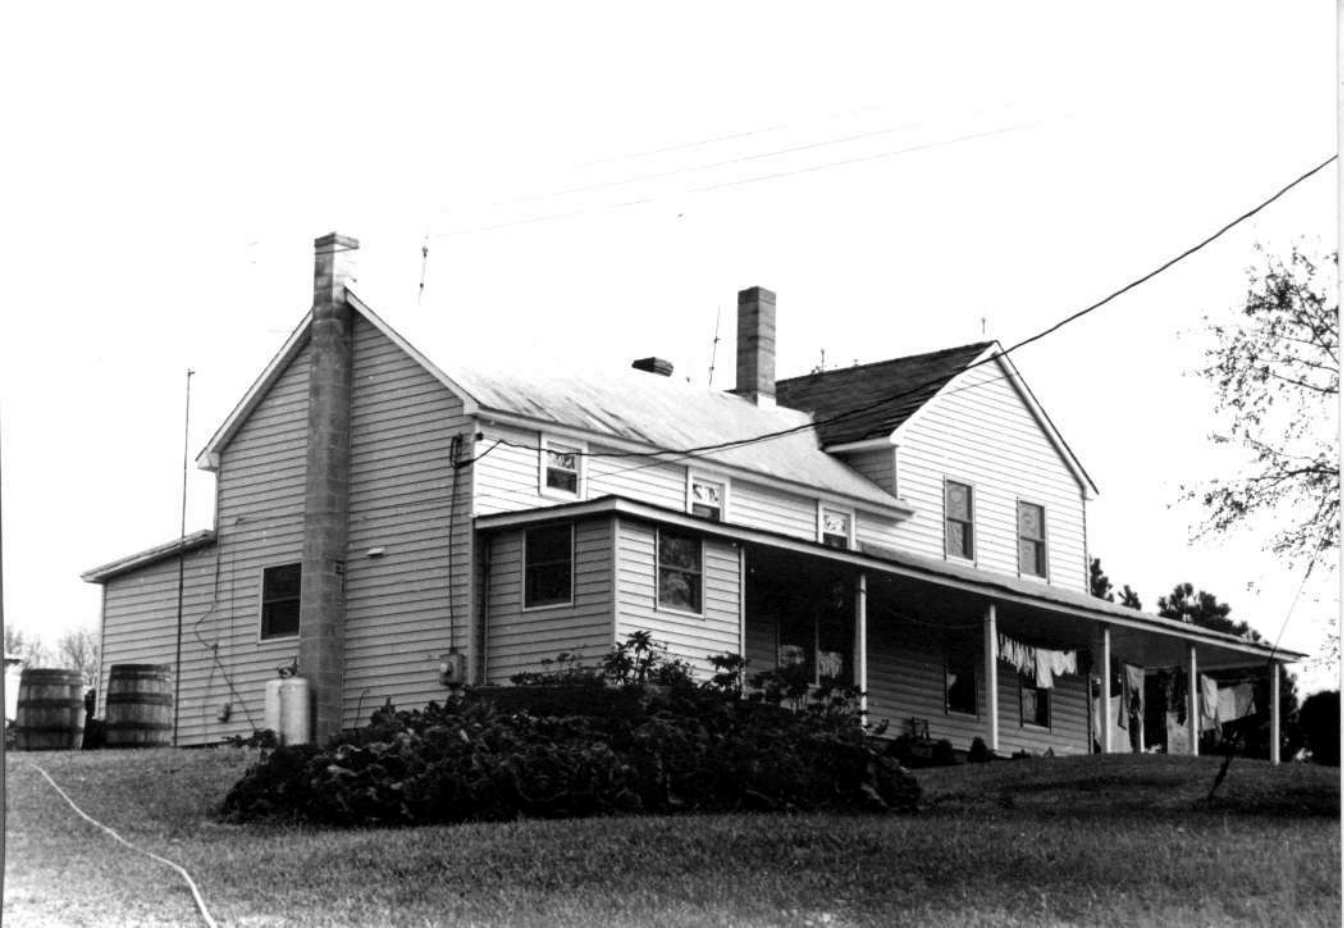
1/5

SW elevation
